GREENHOUSE

SCIENTIFIC DIRECTOR'S REPORT

ANNEX 8.1

BLAST EFFECTS ON AIRCRAFT IN FLIGHT

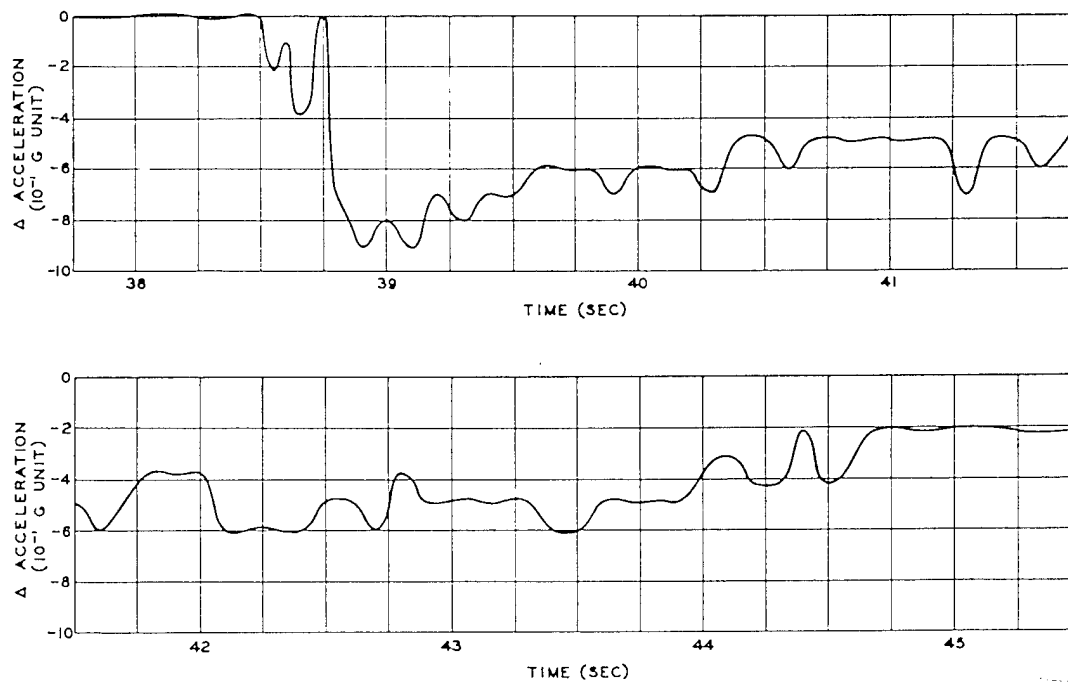
Fig. 5.39 Normal Acceleration, c.g., Channel A7, XB-47, Dog Shot

outer panel bending in the wings measured data which are readable, but the calibration data are not satisfactory. Figure 5.39, c.g. acceleration, may be inaccurate because the noise level was almost as great as the trace deflections.

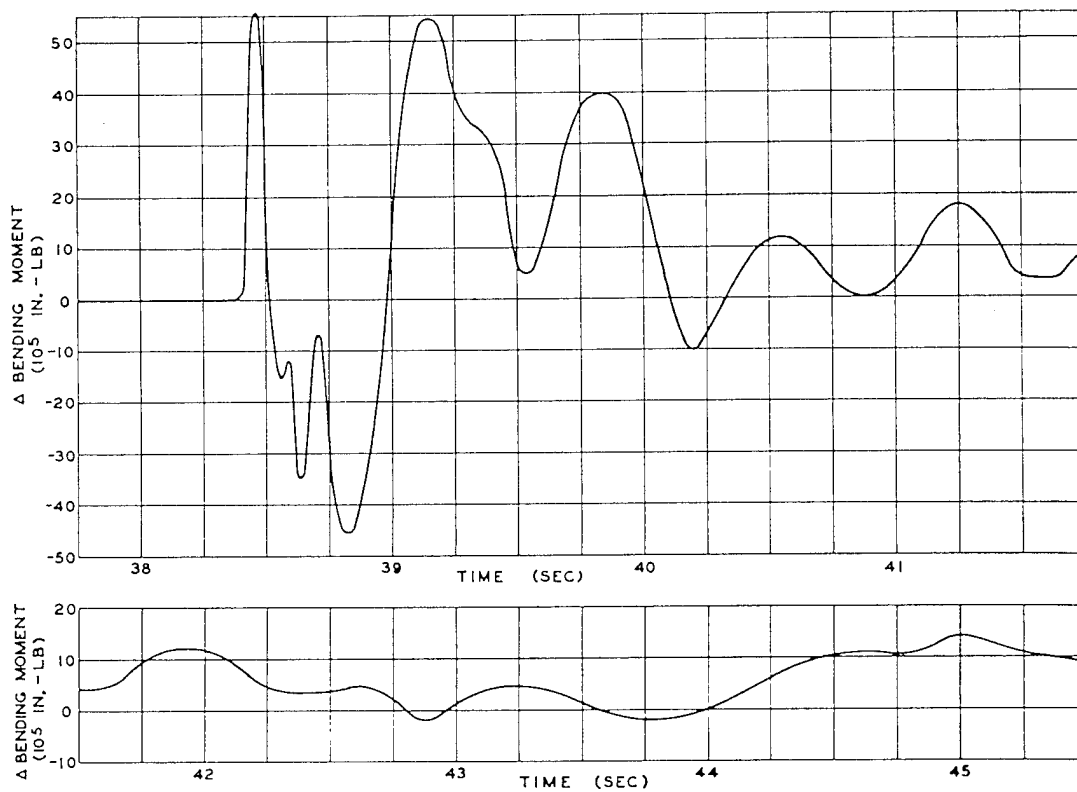
Fig. 5.46 Fuselage Bending, Aft End of Bomb Bay, Fuselage Station 718, Channel A24, XB-47, Dog Shot

Figure 5.46, bending in the fuselage, may be inaccurate, especially in the large deflection, because it was necessary to extrapolate the calibration curve. The calibration of the fuselage-bending gauges was discontinued because of wrinkling and the possibility of permanent deformation of the fuselage.

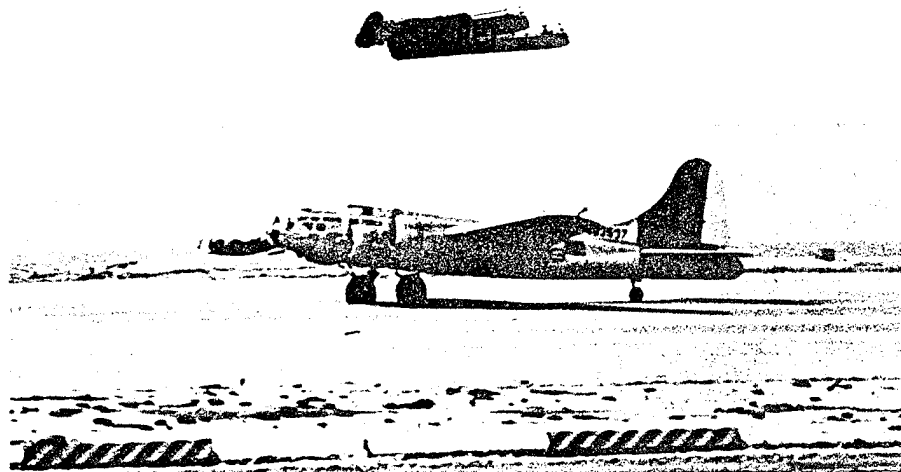
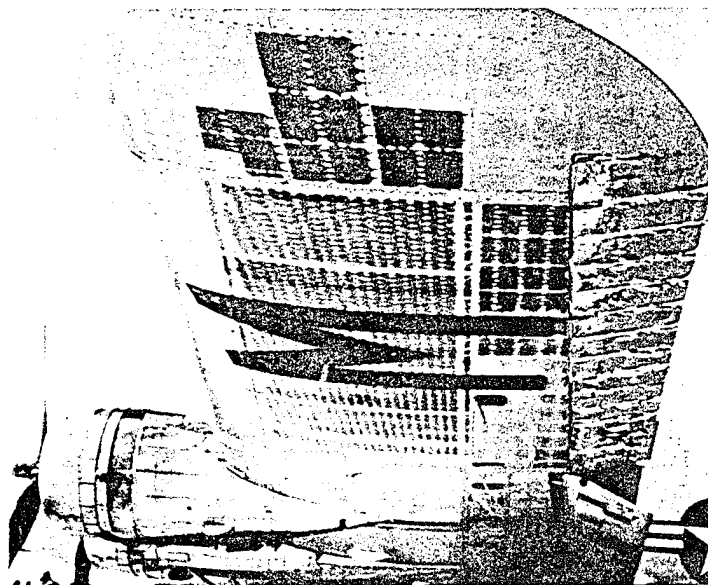
Because of the danger of a ground loop during the landing, this drone was landed last so that obstruction of the runway would not interfere with landing of other drones. The landing was normal, with the drone staying on the runway until just at the end of the landing roll, when it took a slight turn to the right. Pictures of the drone during landing and after stopping are presented in Fig. 6.15, and a close-up of the damage to the tire is shown in Fig. 6.16. The foil protection on the surfaces was burned, as can be seen in Fig. 6.15, but the surfaces themselves were not damaged. The structural damage to the airplane was apparently slight and was limited to pressure damage (rather than gust damage). All the inspection panels on the wings were popped open, as can be seen in Fig. 6.15. The damage to the bomb bay doors is shown in Fig. 6.17. The damage to the canvas cover over the tail-wheel opening, the rear entrance door, and the window in the tail-gunner's compartment, and the displacement of the floor boards in the radio compartment are shown in Fig. 6.18. Another interesting observation concerned damage to the exhaust duct on No. 2 engine, as shown in Fig. 6.19. The logical manner in which this damage could have occurred was for the engine to have been deflected up, with respect to the rest of the nacelle, in such a way that the end of the coupling slipped so far out of the rim of the exhaust duct that it did not return when the engine came back to its normal position. No other damage to the engine mount or nacelle was visible.

Fig. 6.15 Damage to QB-17 Drone M, Easy Shot. A, drone landing with flat tire. B, left wing. C, right wing.

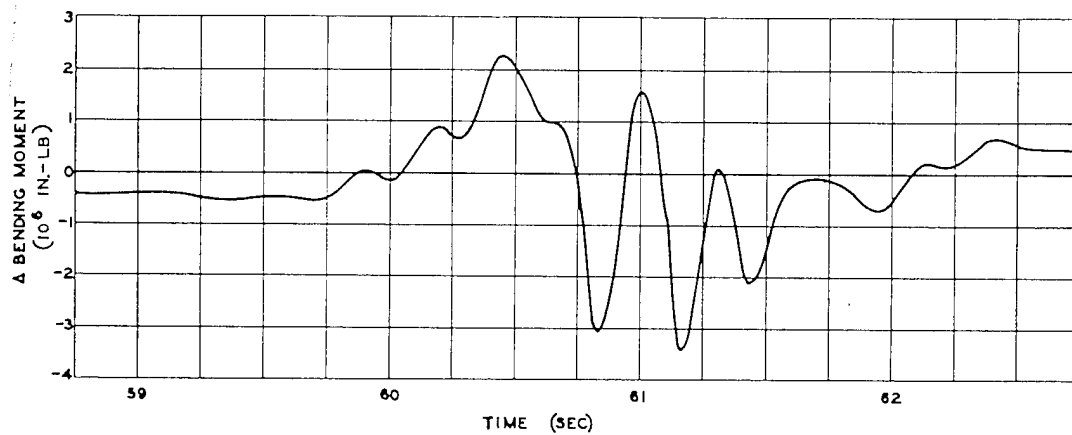
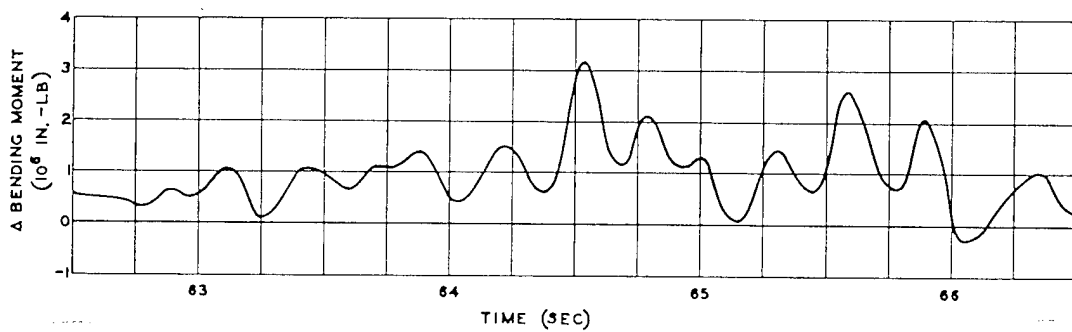
Fig. 6.49 Wing Bending, Left Wing Root, Channel 8, QB-17 N, Cloud Pass, Easy Shot

Although the channels measuring torsion are not shown because of insignificant calibration outputs, the failure of the wing fillets indicates a large torsional load. The torsion at the root (wing station 1) was recorded; however, calibration data are not available to reduce the measurements to actual numbers. The measurements indicate that an increment of torsion at the root of 60 per cent of cal plus occurred at 61.150 sec. The calibrating torsion of 420,000 in.-lb was not discernible on the record; therefore the cloud load must have been at least 10 times that load, or at least 4,200,000 in.-lb. This torsion is negative (leading edge down) and is superimposed on a peak of bending moment at the root of approximately 2,780,000 in.-lb as indicated by the measurements on the

opposite wing, Fig. 6.49. This combination of negative torsion and positive bending would have been additive on the rear spar and accounts for the failure in the fairing. Thus the bending at the rear spar amounted to about 3,900,000 in.-lb and that at the front spar amounted to about 380,000 in.-lb. This amounts to approximately 85 per cent of the limit load on the rear spar.

A comparison of the loads from the shock and from the cloud justifies the preliminary assumption that the structural damage was caused by the turbulence in the cloud. Obviously this drone was in the most turbulent area of the cloud, the "puff," at a very low altitude. A computation of the gust velocities has not been attempted, but they would probably exceed 150 to 200 ft/sec. One pertinent conclusion to be drawn from these data is that a rugged airframe is a necessity for any drone which is used to enter the cloud, where the drone is likely to encounter gusts of such velocities. These loads illustrate the conditions which, fortunately, have been avoided by the cloud-sampling drones in the past tests.
